Proposed Subdivision -
Hereford Hill,
Stages 1 & 2
Site Classification

Lot 11, DP 1248129, New
England Highway,
Lochinvar

NEW17P-0054A-AD
30 April 2021

**RE: PROPOSED SUBDIVISION – HEREFORD HILL, STAGES 1 & 2
LOT 11, DP 1248129, NEW ENGLAND HIGHWAY, LOCHINVAR
SITE CLASSIFICATION (LOTS 101 TO 136, AND LOTS 201 TO 220)**

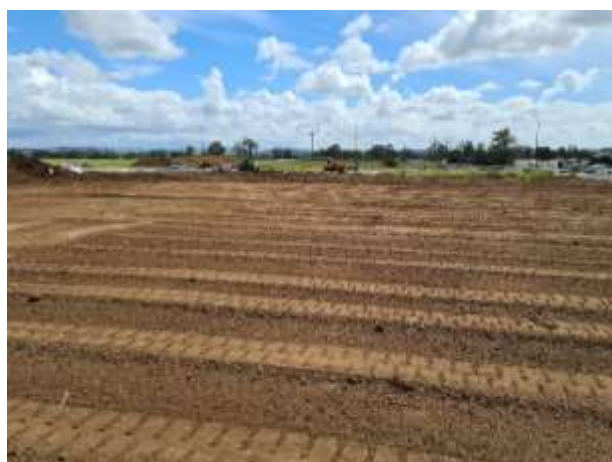
Photograph 14: Facing west from near BH111.

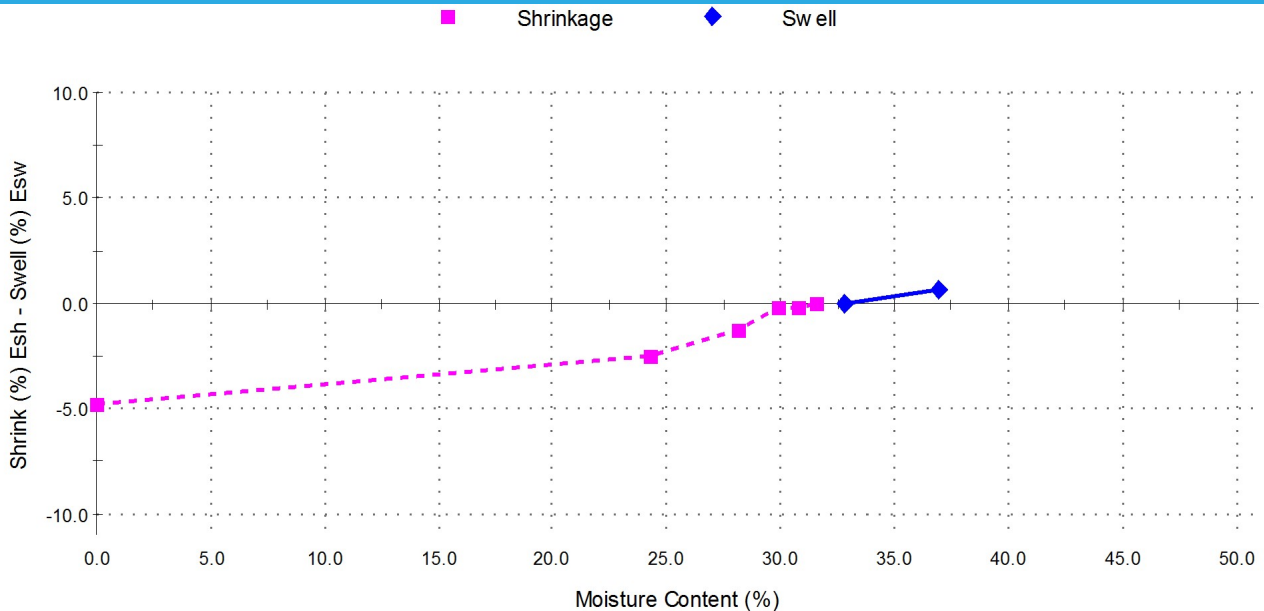
AS 1289.7.1.1	AS 1289.7.1.1
Swell Test	Shrink Test
Swell on Saturation (%): 0.6	Shrink on drying (%): 4.8
Moisture Content before (%): 32.8	Shrinkage Moisture Content (%): 31.5
Moisture Content after (%): 36.9	Est. inert material (%): 1%
Est. Unc. Comp. Strength before (kPa): 310	Crumbling during shrinkage: Nil
Est. Unc. Comp. Strength after (kPa): 170	Cracking during shrinkage: Major

Shrink Swell Index - Iss (%): 2.8

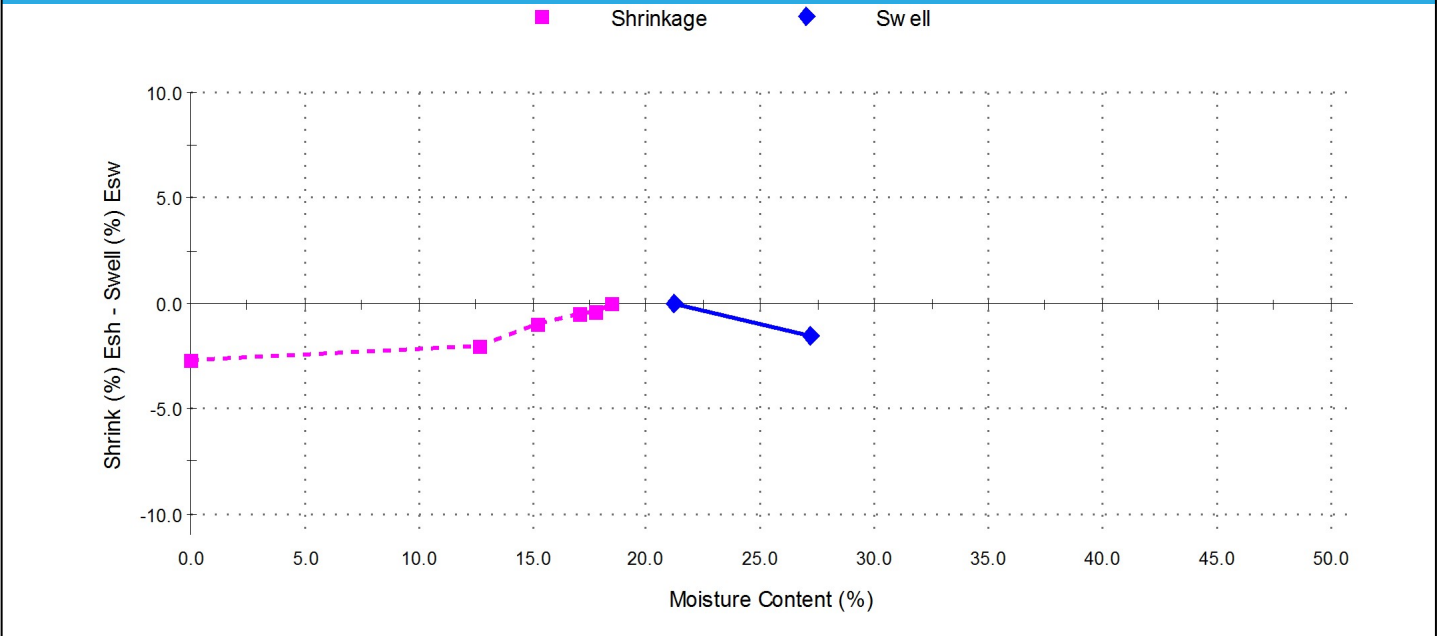
Swell Test AS 1289.7.1.1		Shrink Test AS 1289.7.1.1	
Swell on Saturation (%):	-1.6	Shrink on drying (%):	2.7
Moisture Content before (%):	21.2	Shrinkage Moisture Content (%):	18.4
Moisture Content after (%):	27.2	Est. inert material (%):	7%
Est. Unc. Comp. Strength before (kPa):	>600	Crumbling during shrinkage:	Nil
Est. Unc. Comp. Strength after (kPa):	450	Cracking during shrinkage:	Minor

Shrink Swell Index - Iss (%): 1.5

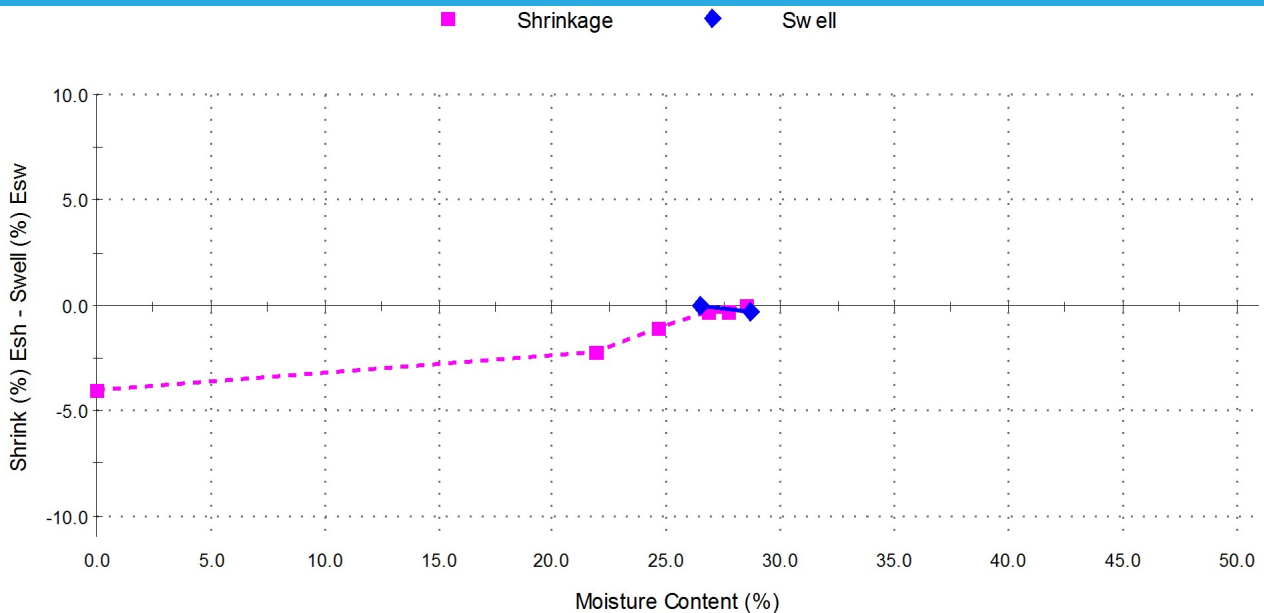
Swell Test AS 1289.7.1.1		Shrink Test AS 1289.7.1.1	
Swell on Saturation (%):	-0.3	Shrink on drying (%):	4.0
Moisture Content before (%):	26.5	Shrinkage Moisture Content (%):	28.5
Moisture Content after (%):	28.7	Est. inert material (%):	7%
Est. Unc. Comp. Strength before (kPa):	>600	Crumbling during shrinkage:	Nil
Est. Unc. Comp. Strength after (kPa):	550	Cracking during shrinkage:	Minor

Shrink Swell Index - Iss (%): 2.2

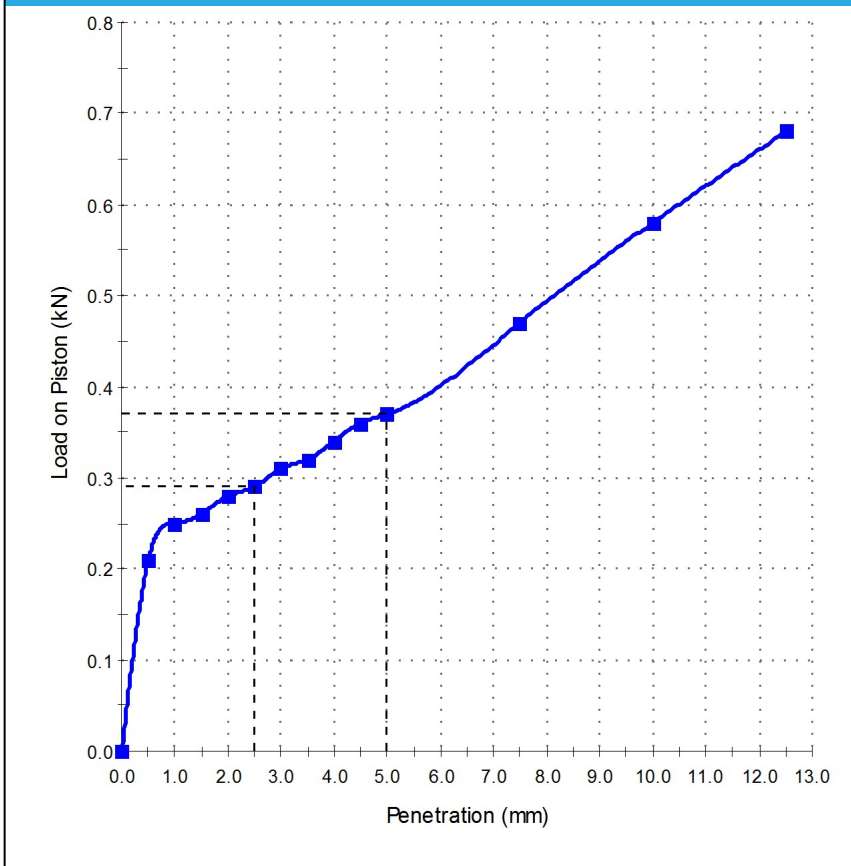
Load vs Penetration

AS 1289.6.1.1
