Proposed Subdivision Hereford Hill Stage 11 and 12 Site Classification

Gregory Road and Silo Street, Lochinvar

NEW17P-0054C-AD 3 November 2021

RE: PROPOSED SUBDIVISION – HEREFORD HILL – STAGE 11 & 12
GREGORY ROAD & SILO STREET, LOCHINVAR
SITE CLASSIFICATION (LOTS 1101 TO 1113 AND 1201 TO 1214)

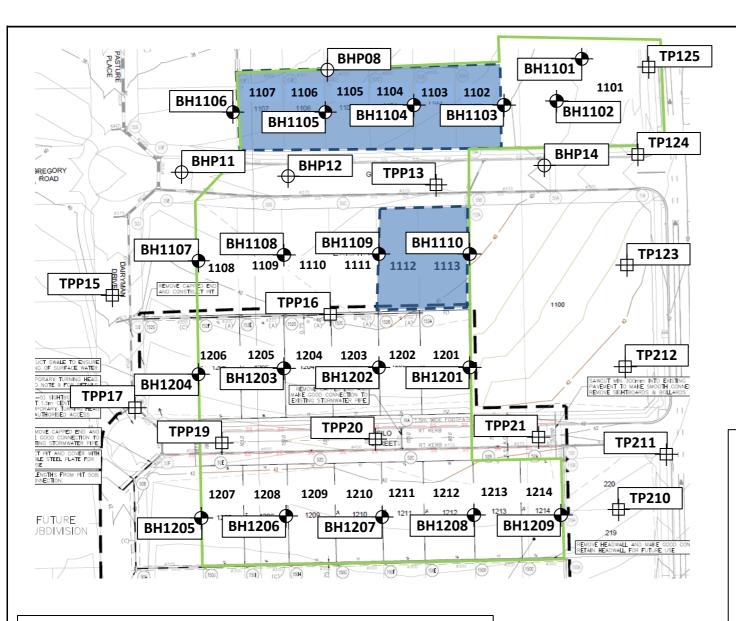
# **FIGURE AD1:**

Site Plan and Approximate Test Locations

Figure AD1: Site Plan and Approximate Test Locations

Based on the results of the field work, laboratory testing and site regrade works conducted, residential lots located within Stages 11 and 12 of the Hereford Hill residential subdivision, as shown on the attached Figure AD1, are classified in their current condition in accordance with AS2870-2011 'Residential Slabs and Footings', as shown in Table 5.

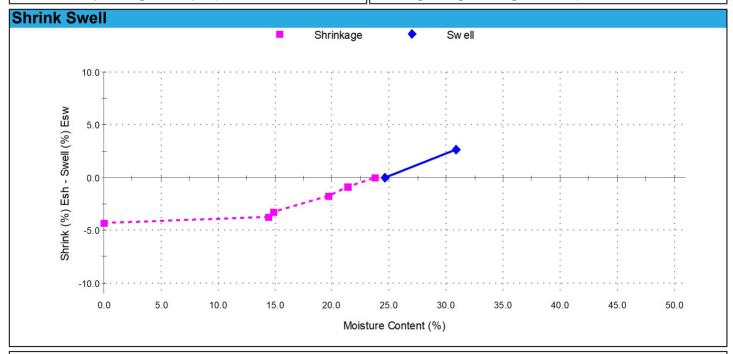
#### **Shrink Test** AS 1289.7.1.1

Shrink on drying (%): Shrinkage Moisture Content (%): 23.7 Est. inert material (%): 10 Crumbling during shrinkage: Nil Cracking during shrinkage: Major

Shrink Swell Index - Iss (%): 3.1

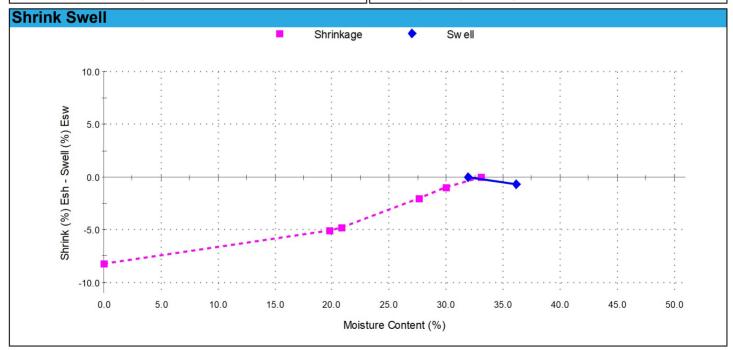
Swell Test	AS 1289.7.1.1	Shrink Test	AS 1289.7.1.1
Swell on Saturation (%):	-0.7	Shrink on drying (%):	8.2
Moisture Content before (%):	32.0	Shrinkage Moisture Content (%):	33.0
Moisture Content after (%):	36.2	Est. inert material (%):	2%
Est. Unc. Comp. Strength before (kPa)	: 130	Crumbling during shrinkage:	Nil
Est. Unc. Comp. Strength after (kPa):	100	Cracking during shrinkage:	Nil

Shrink Swell Index - Iss (%): 4.6

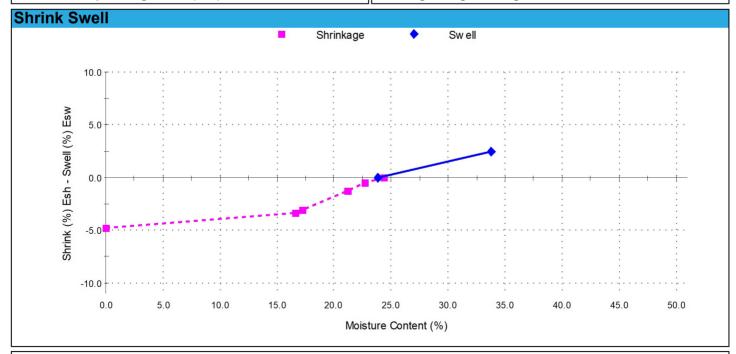
#### **Shrink Test** AS 1289.7.1.1

Shrink on drying (%): Shrinkage Moisture Content (%): 24.4 Est. inert material (%): Crumbling during shrinkage: Nil Cracking during shrinkage: Moderate

Shrink Swell Index - Iss (%): 3.3

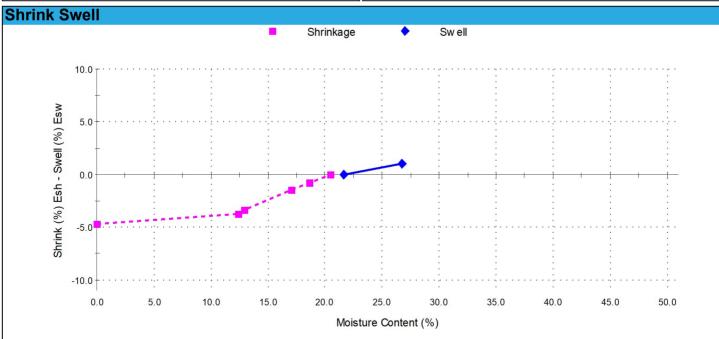
#### **Shrink Test** AS 1289.7.1.1

Shrink on drying (%): Shrinkage Moisture Content (%): 20.5 Est. inert material (%): 10 Crumbling during shrinkage: Nil Cracking during shrinkage: Minor

Shrink Swell Index - Iss (%): 2.9

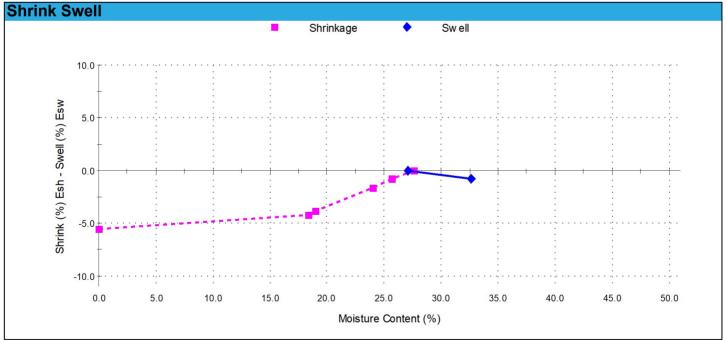
Shrink on drying (%): Shrinkage Moisture Content (%): 27.6 Est. inert material (%): Crumbling during shrinkage: Nil Cracking during shrinkage: Minor

AS 1289.7.1.1 **Swell Test** Swell on Saturation (%): Moisture Content before (%): 27.1 Moisture Content after (%): 32.6 Est. Unc. Comp. Strength before (kPa): 260 Est. Unc. Comp. Strength after (kPa):

Shrink Swell Index - Iss (%): 3.1

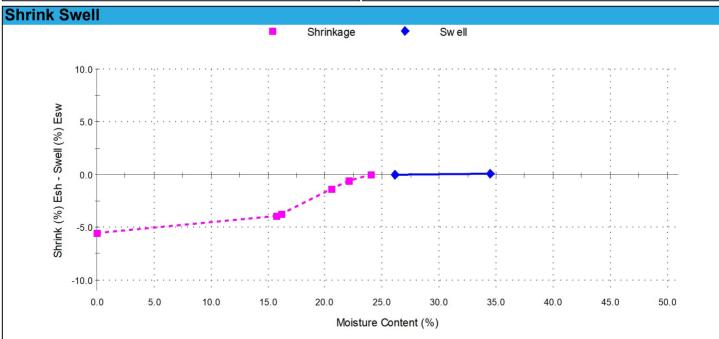
#### **Shrink Test** AS 1289.7.1.1

Shrink on drying (%): Shrinkage Moisture Content (%): 24.0 Est. inert material (%): Crumbling during shrinkage: Nil Cracking during shrinkage: Minor

Shrink Swell Index - Iss (%): 3.1

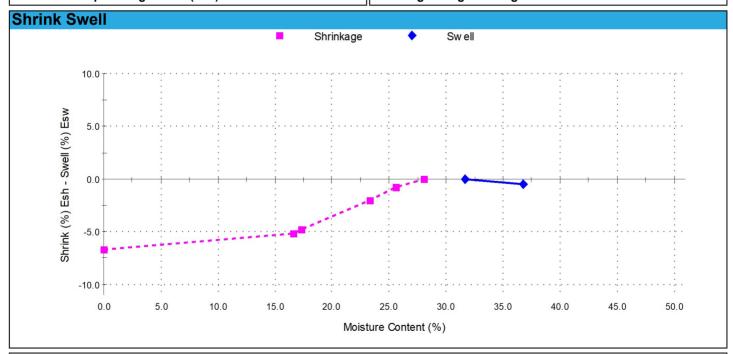
Swell Test	AS 1289.7.1.1	Shrink Test	AS 1289.7.1.1
Swell on Saturation (%):	-0.5	Shrink on drying (%): 6	5.7
Moisture Content before (%):	31.7	Shrinkage Moisture Content (%): 2	8.1
Moisture Content after (%):	36.7	Est. inert material (%):	%
Est. Unc. Comp. Strength before (k	<b>Pa):</b> 250	Crumbling during shrinkage: N	lil
Est. Unc. Comp. Strength after (kP	a): 100	Cracking during shrinkage:	Moderate

Shrink Swell Index - Iss (%): 3.7

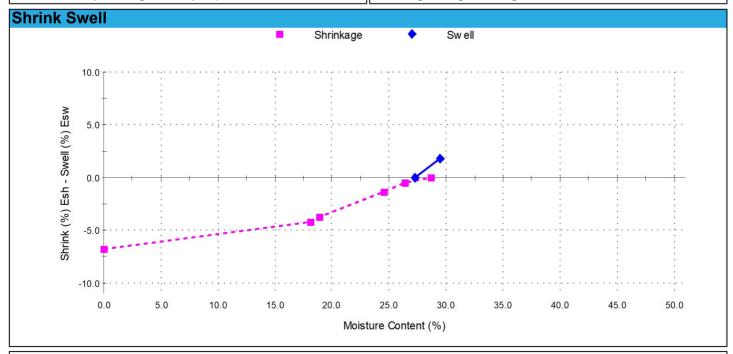
#### **Shrink Test** AS 1289.7.1.1

Shrink on drying (%): Shrinkage Moisture Content (%): 28.7 Est. inert material (%): Crumbling during shrinkage: Nil Cracking during shrinkage: Minor

Shrink Swell Index - Iss (%): 4.3

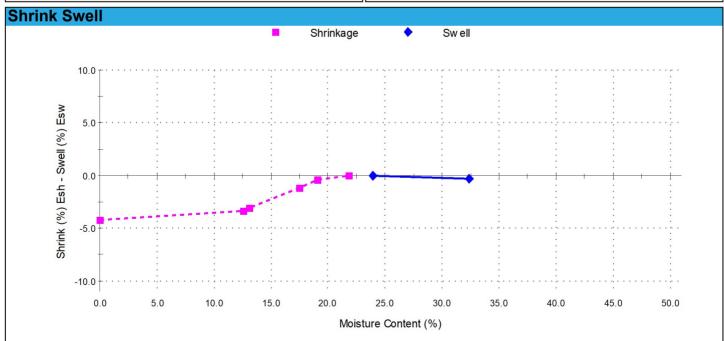
#### **Shrink Test** AS 1289.7.1.1

Shrink on drying (%): Shrinkage Moisture Content (%): 21.8 Est. inert material (%): Crumbling during shrinkage: Nil Cracking during shrinkage: Moderate

Shrink Swell Index - Iss (%): 2.3

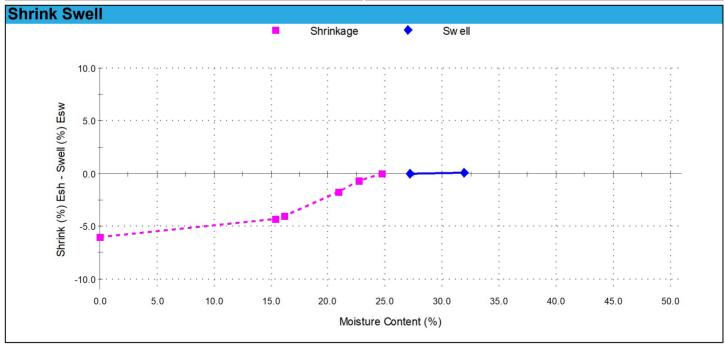
#### **Shrink Test** AS 1289.7.1.1

Shrink on drying (%): Shrinkage Moisture Content (%): 24.7 Est. inert material (%): Crumbling during shrinkage: Nil Cracking during shrinkage: Minor

Shrink Swell Index - Iss (%): 3.4

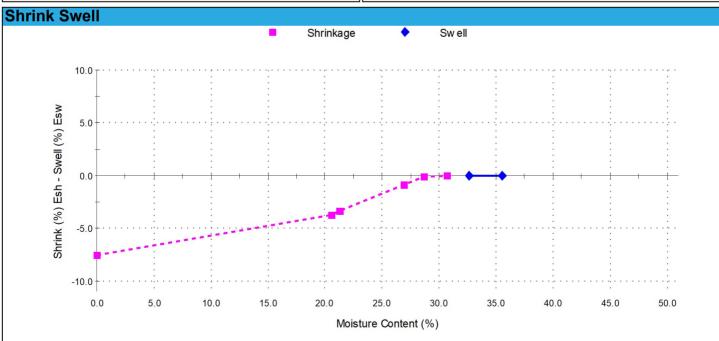
**Shrink Test** AS 1289.7.1.1

AS 1289.7.1.1 **Swell Test** Swell on Saturation (%): Shrink on drying (%): Moisture Content before (%): Shrinkage Moisture Content (%): 30.7 32.6 Moisture Content after (%): 35.5 Est. inert material (%): Est. Unc. Comp. Strength before (kPa): 170 Crumbling during shrinkage: Nil Est. Unc. Comp. Strength after (kPa): Cracking during shrinkage: Major

Shrink Swell Index - Iss (%): 4.2

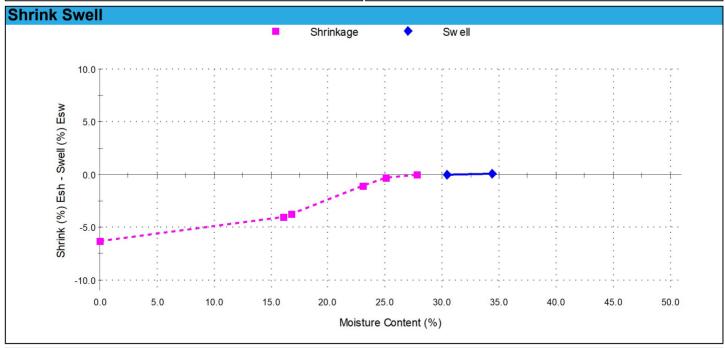
#### **Shrink Test** AS 1289.7.1.1

Shrink on drying (%): Shrinkage Moisture Content (%): 27.8 Est. inert material (%): Crumbling during shrinkage: Nil Cracking during shrinkage: Nil

Shrink Swell Index - Iss (%): 3.5

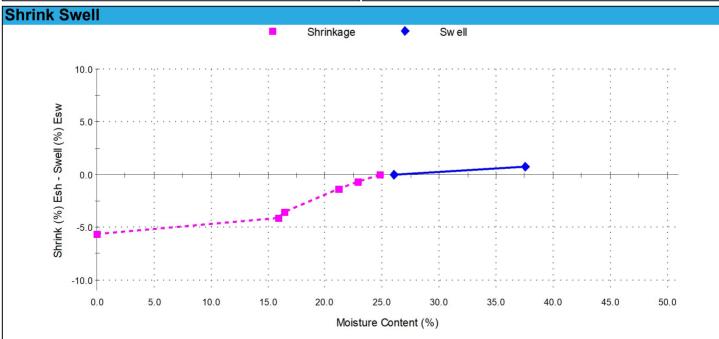
#### **Shrink Test** AS 1289.7.1.1

Shrink on drying (%): Shrinkage Moisture Content (%): 24.8 Est. inert material (%): Crumbling during shrinkage: Nil Cracking during shrinkage: Minor

Shrink Swell Index - Iss (%): 3.4

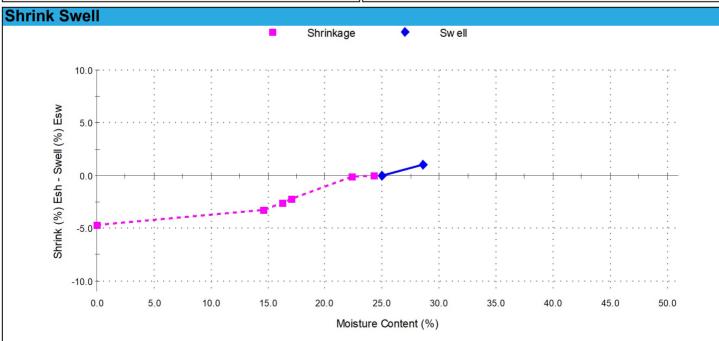
#### **Shrink Test** AS 1289.7.1.1

Shrink on drying (%): Shrinkage Moisture Content (%): 24.3 Est. inert material (%): Crumbling during shrinkage: Nil Cracking during shrinkage: Minor

Shrink Swell Index - Iss (%): 2.9

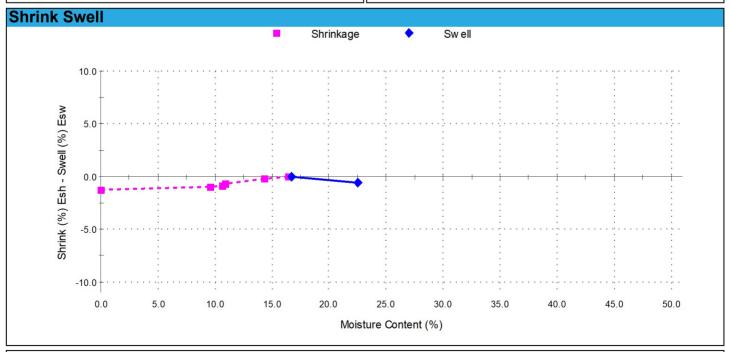
#### **Shrink Test** AS 1289.7.1.1

Shrink on drying (%): Shrinkage Moisture Content (%): 16.4 Est. inert material (%): Crumbling during shrinkage: Nil Cracking during shrinkage: Major

Shrink Swell Index - Iss (%): 0.7

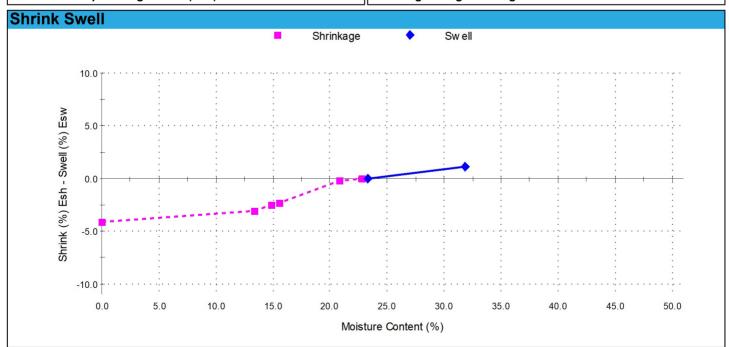
#### **Shrink Test** AS 1289.7.1.1

Shrink on drying (%): Shrinkage Moisture Content (%): 22.7 Est. inert material (%): Crumbling during shrinkage: Nil Cracking during shrinkage: Minor

Shrink Swell Index - Iss (%): 2.6

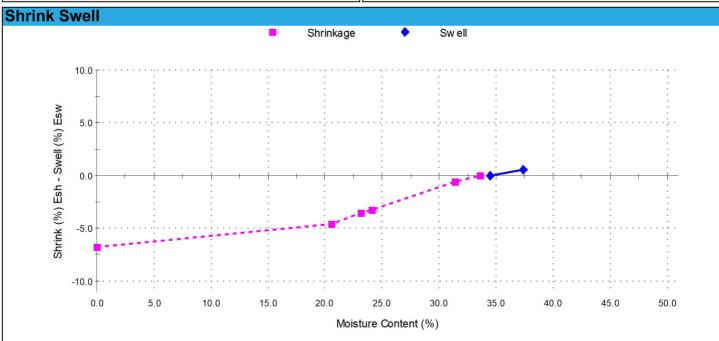
#### **Shrink Test** AS 1289.7.1.1

Shrink on drying (%): Shrinkage Moisture Content (%): 33.6 Est. inert material (%): Crumbling during shrinkage: Nil Cracking during shrinkage: Minor

Shrink Swell Index - Iss (%): 3.9

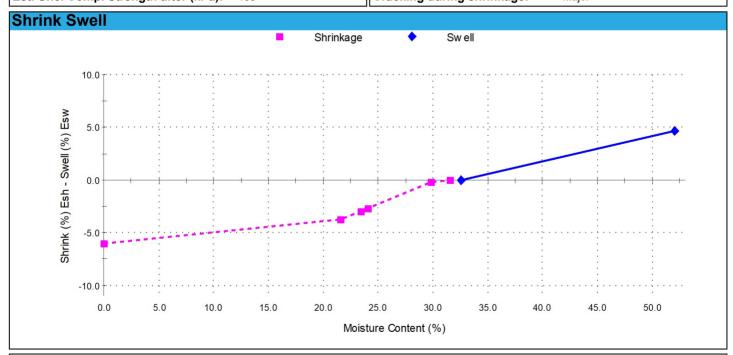
AS 1289.7.1.1 AS 1289.7.1.1 Swell Test **Shrink Test** Swell on Saturation (%): Shrink on drying (%): 4.7 Moisture Content before (%): Shrinkage Moisture Content (%): 31.5 32.6 Moisture Content after (%): Est. inert material (%): Est. Unc. Comp. Strength before (kPa): 540 Crumbling during shrinkage: Nil Est. Unc. Comp. Strength after (kPa): Cracking during shrinkage: Major

Shrink Swell Index - Iss (%): 4.6

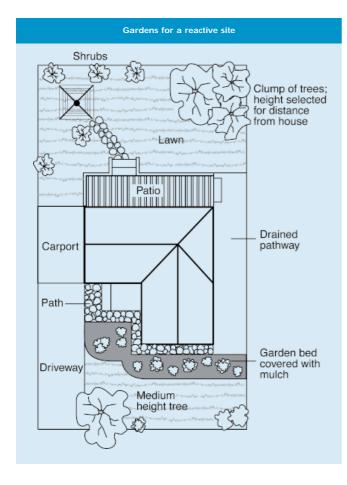
For this reason, particularly where problems exist or are likely to occur, it is recommended that an apron of paving be installed around as much of the building perimeter as necessary. This paving

should extend outwards a minimum of 900 mm (more in highly reactive soil) and should have a minimum fall away from the building of 1:60. The finished paving should be no less than 100 mm below brick vent bases.
