Proposed Subdivision
Hereford Hill - Stage 5
Site Classification

Springfield Drive, Lochinvar

NEW17P-0054B-AG
10 July 2024

**RE: PROPOSED SUBDIVISION – HEREFORD HILL, STAGE 5
SPRINGFIELD DRIVE, LOCHINVAR
SITE CLASSIFICATION (LOTS 501 TO 524)**

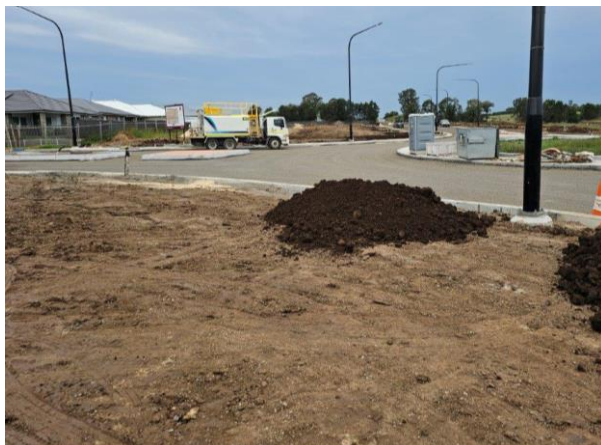
Photograph 1: From near BH501, facing east.

Selected photographs of the site taken on the day of the site investigation, are shown below.

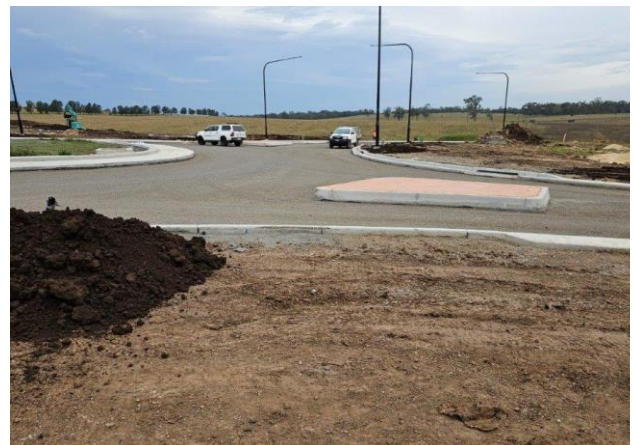
Photograph 2: From near BH501, facing south.

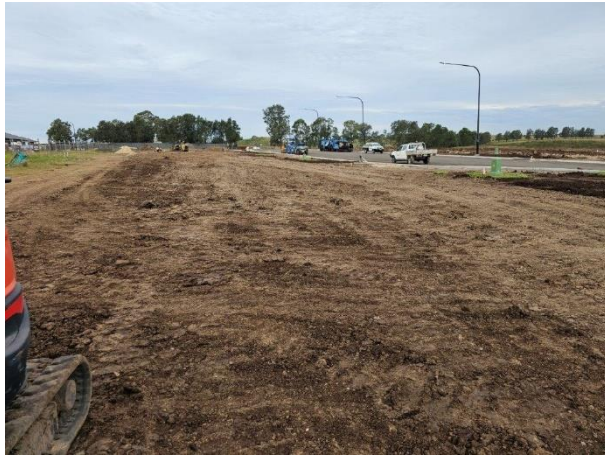
Photograph 3: From near BH502, facing southeast.

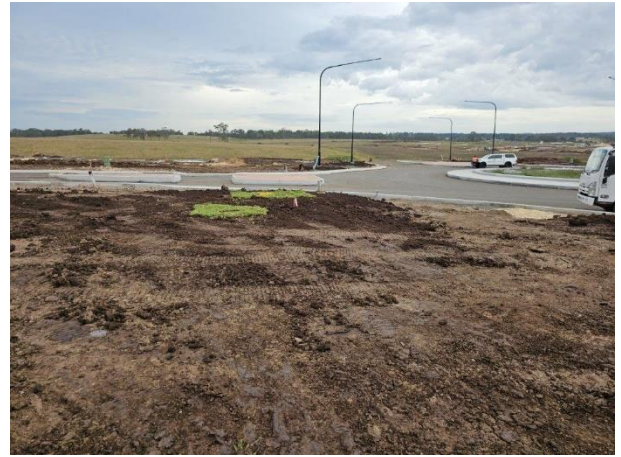
Photograph 4: Near BH502 facing southwest.

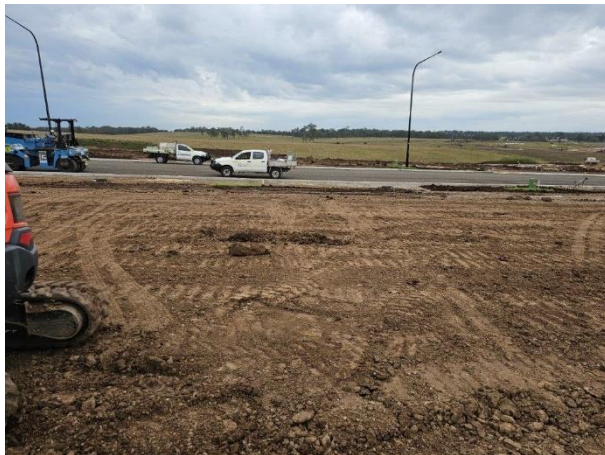
Photograph 5: From near BH504 facing south.

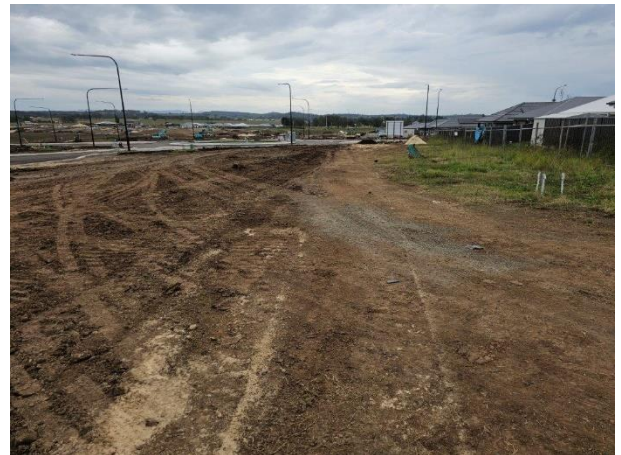
Photograph 6: From near BH504 facing west.

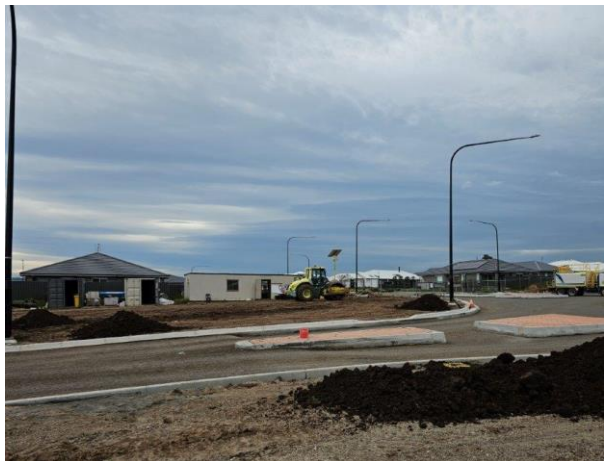
Photograph 7: From near BH506, facing northeast.

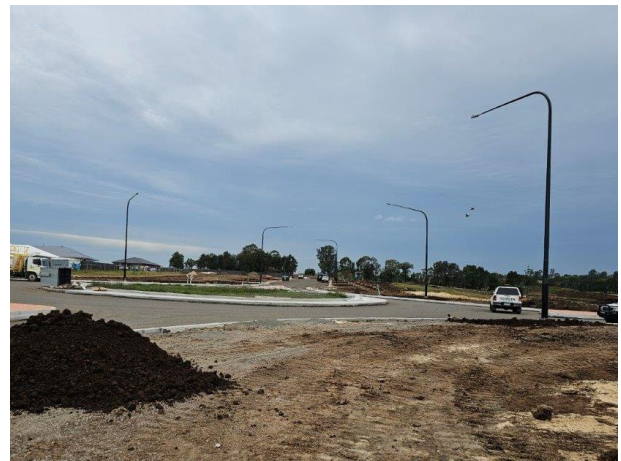
Photograph 8: From near BH506, facing east.

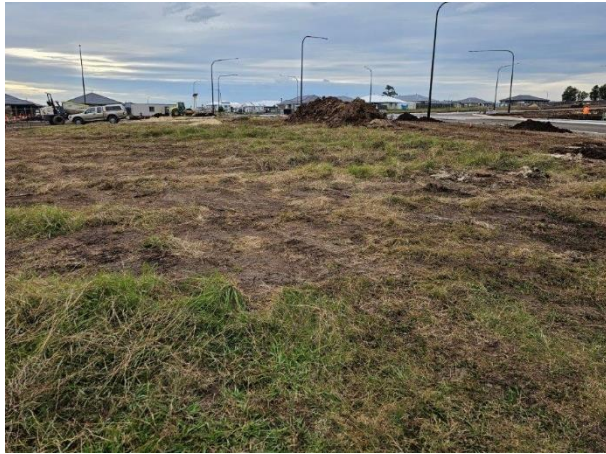
Photograph 9: From BH508, facing northeast.

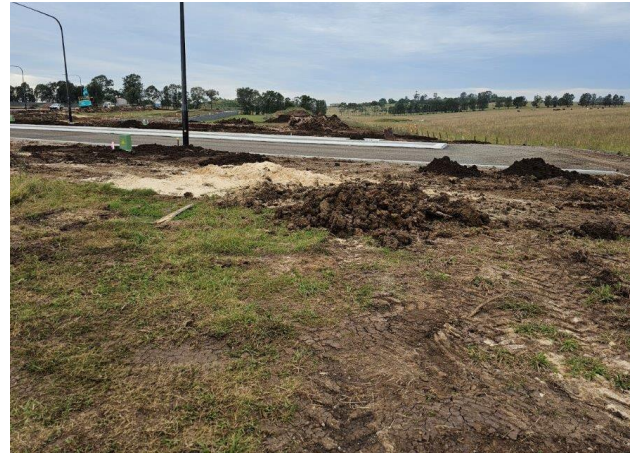
Photograph 10: Near BH508, facing east.

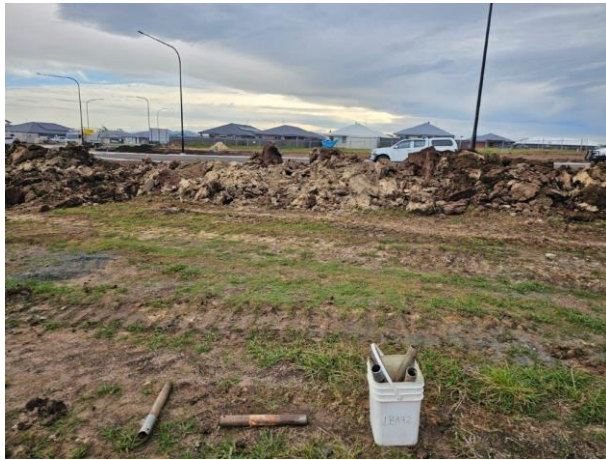
Photograph 11: From near BH510, facing north.

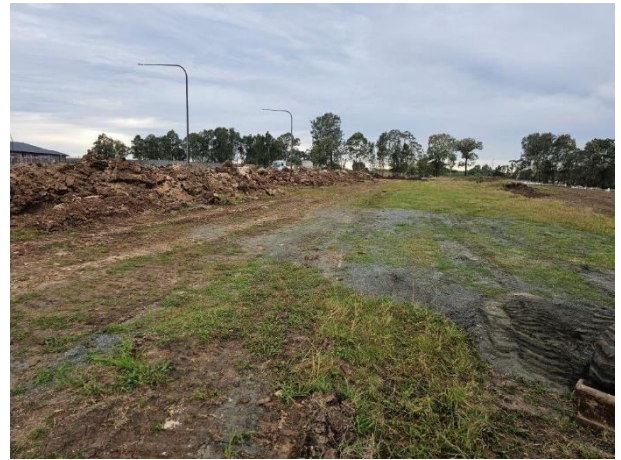
Photograph 12: From near BH06, facing east.

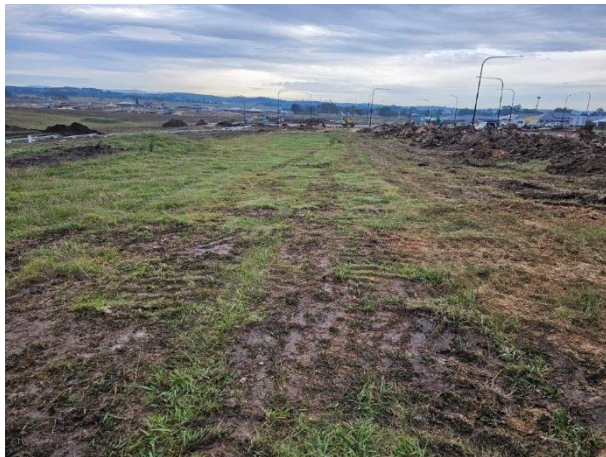
Photograph 13: From near BH513, facing northwest.

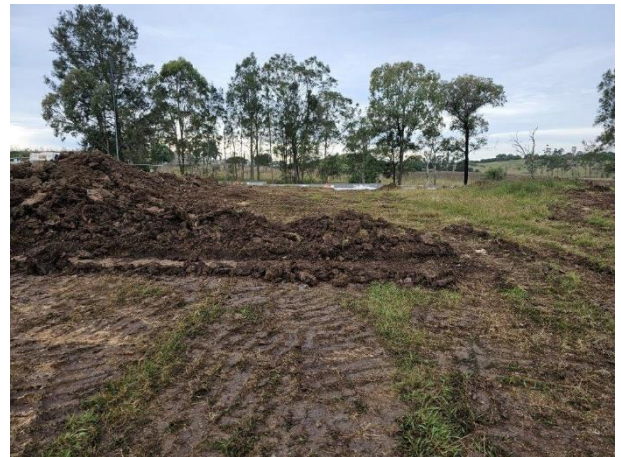
Photograph 14: Near BH513, facing east.

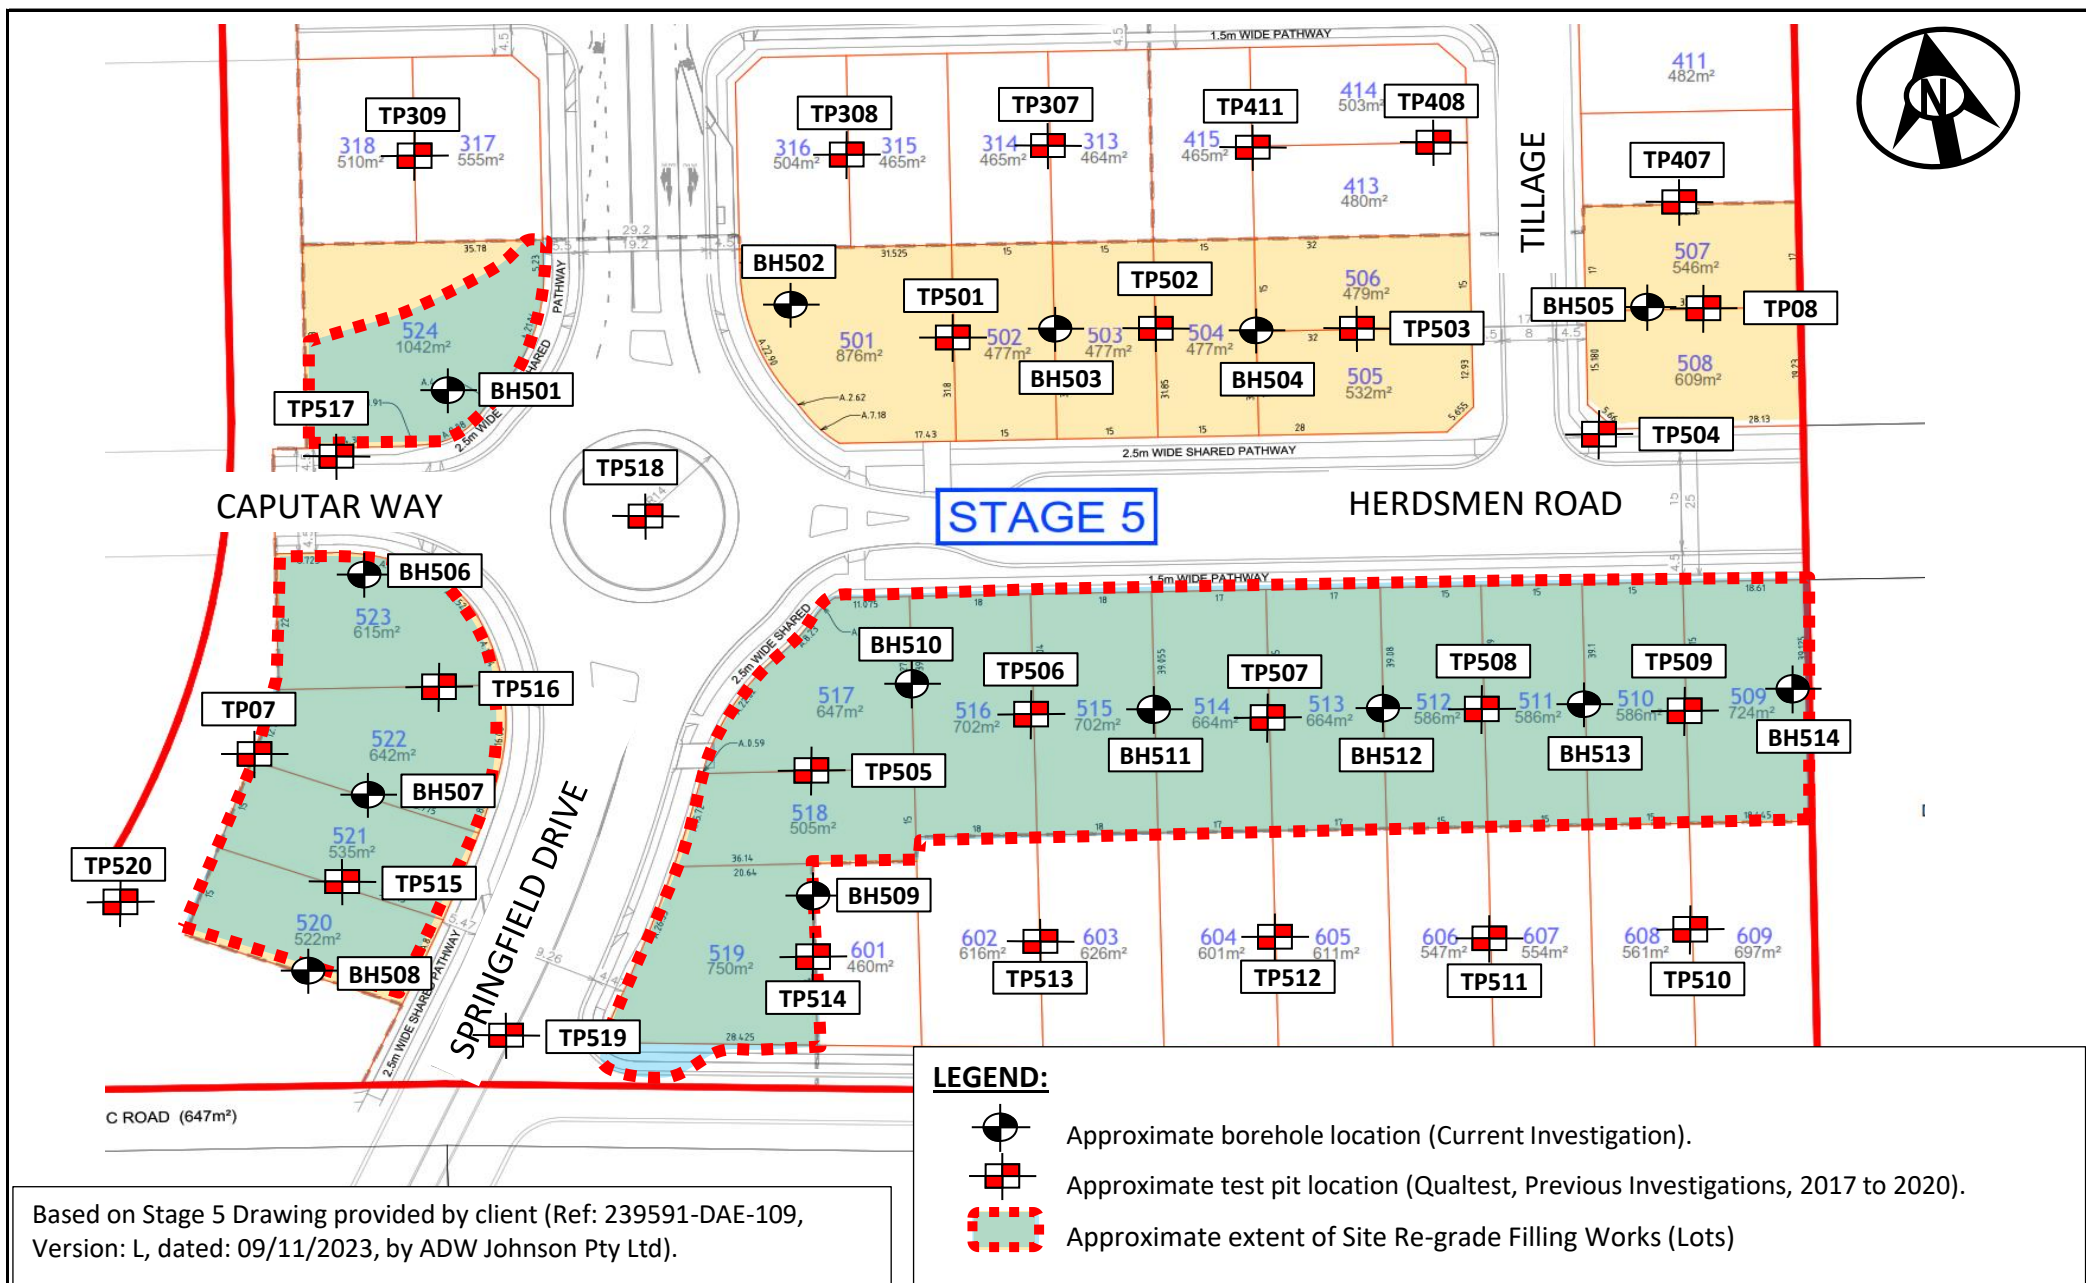
Figure AG1

Site Plan and Approximate Test Locations

Based on Stage 5 Drawing provided by client (Ref: 239591-DAE-109, Version: L, dated: 09/11/2023, by ADW Johnson Pty Ltd).

Figure AG1: Site Plan & Approximate Test Locations

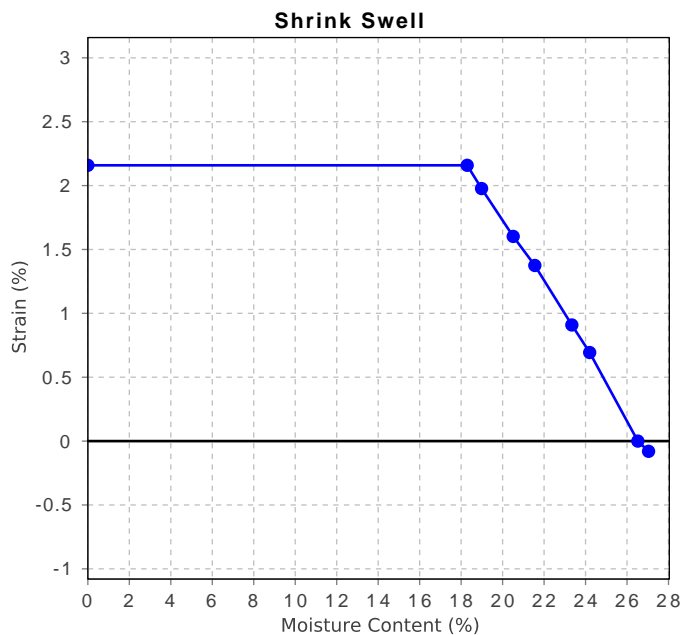
Shrink Swell Index (AS 1289 7.1.1 & 2.1.1)	
Iss (%)	1.2
Visual Description	Clay
* Shrink Swell Index (Iss) reported as the percentage vertical strain per pF change in suction.	
Core Shrinkage Test	
Shrinkage Strain - Oven Dried (%)	2.2
Estimated % by volume of significant inert inclusions	2
Cracking	Slightly Cracked
Crumbling	No
Moisture Content (%)	26.5
Swell Test	
Initial Pocket Penetrometer (kPa)	340
Final Pocket Penetrometer (kPa)	280
Initial Moisture Content (%)	24.1
Final Moisture Content (%)	27.0
Swell (%)	0.1
* NATA Accreditation does not cover the performance of pocket penetrometer readings.

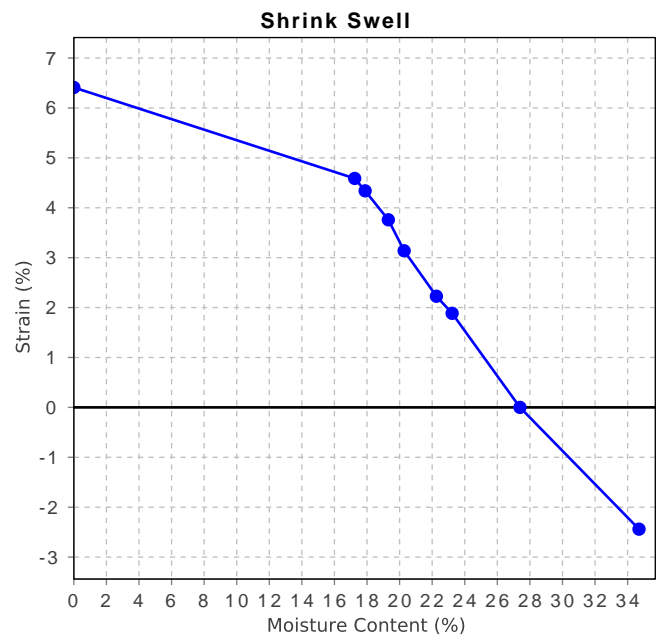
Shrink Swell Index (AS 1289 7.1.1 & 2.1.1)	
Iss (%)	4.2
Visual Description	Clay
* Shrink Swell Index (Iss) reported as the percentage vertical strain per pF change in suction.	
Core Shrinkage Test	
Shrinkage Strain - Oven Dried (%)	6.4
Estimated % by volume of significant inert inclusions	1
Cracking	Uncracked
Crumbling	No
Moisture Content (%)	27.4
Swell Test	
Initial Pocket Penetrometer (kPa)	230
Final Pocket Penetrometer (kPa)	230
Initial Moisture Content (%)	32.1
Final Moisture Content (%)	34.7
Swell (%)	2.4
* NATA Accreditation does not cover the performance of pocket penetrometer readings.

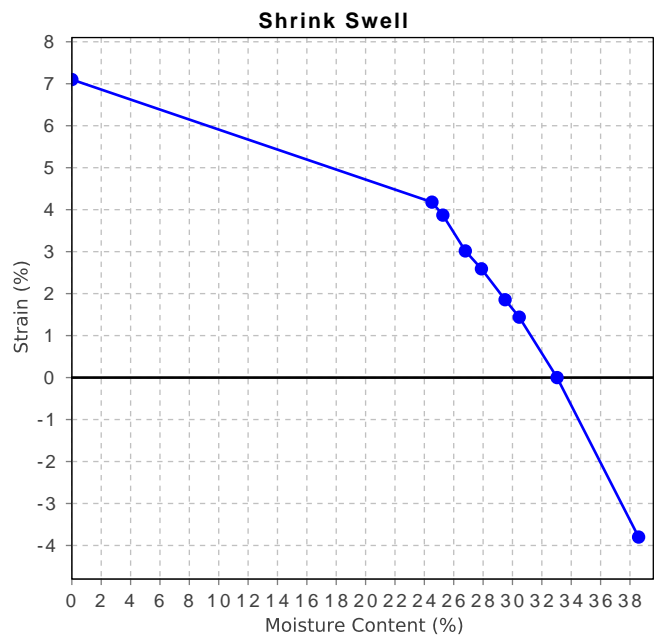
Shrink Swell Index (AS 1289 7.1.1 & 2.1.1)	
Iss (%)	5.0
Visual Description	Clay
* Shrink Swell Index (Iss) reported as the percentage vertical strain per pF change in suction.	
Core Shrinkage Test	
Shrinkage Strain - Oven Dried (%)	7.1
Estimated % by volume of significant inert inclusions	1
Cracking	Uncracked
Crumbling	No
Moisture Content (%)	33.0
Swell Test	
Initial Pocket Penetrometer (kPa)	200
Final Pocket Penetrometer (kPa)	240
Initial Moisture Content (%)	39.3
Final Moisture Content (%)	38.6
Swell (%)	3.8
* NATA Accreditation does not cover the performance of pocket penetrometer readings.

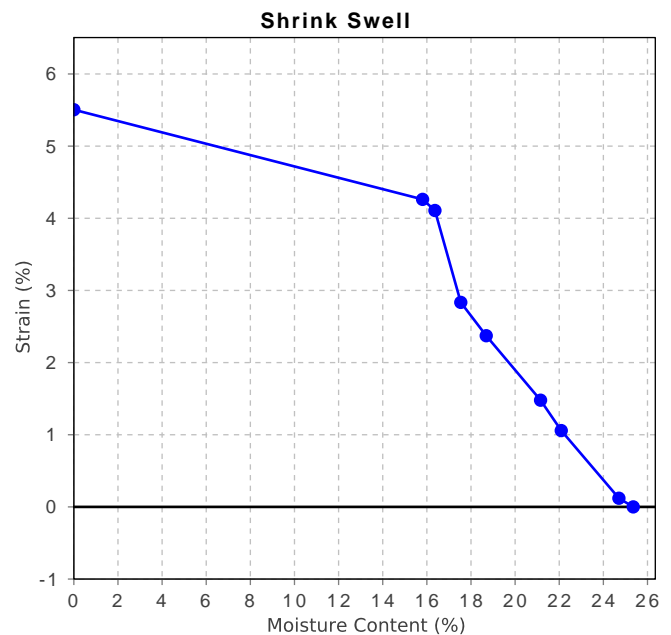
Shrink Swell Index (AS 1289 7.1.1 & 2.1.1)	
Iss (%)	3.1
Visual Description	Clay
* Shrink Swell Index (Iss) reported as the percentage vertical strain per pF change in suction.	
Core Shrinkage Test	
Shrinkage Strain - Oven Dried (%)	5.5
Estimated % by volume of significant inert inclusions	1
Cracking	Moderately Cracked
Crumbling	No
Moisture Content (%)	25.4
Swell Test	
Initial Pocket Penetrometer (kPa)	220
Final Pocket Penetrometer (kPa)	280
Initial Moisture Content (%)	20.0
Final Moisture Content (%)	24.7
Swell (%)	-0.1
* NATA Accreditation does not cover the performance of pocket penetrometer readings.

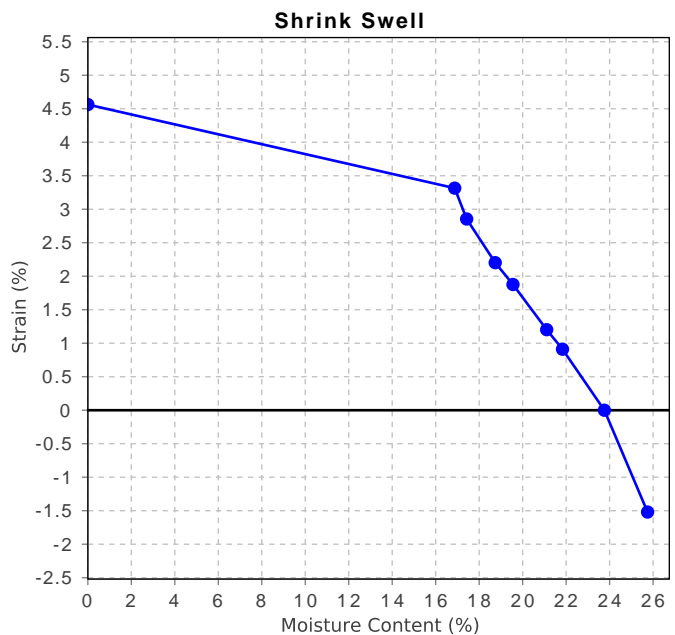
Shrink Swell Index (AS 1289 7.1.1 & 2.1.1)	
Iss (%)	3.0
Visual Description	Clay
* Shrink Swell Index (Iss) reported as the percentage vertical strain per pF change in suction.	
Core Shrinkage Test	
Shrinkage Strain - Oven Dried (%)	4.6
Estimated % by volume of significant inert inclusions	1
Cracking	Uncracked
Crumbling	No
Moisture Content (%)	23.8
Swell Test	
Initial Pocket Penetrometer (kPa)	>600
Final Pocket Penetrometer (kPa)	300
Initial Moisture Content (%)	22.5
Final Moisture Content (%)	25.7
Swell (%)	1.5
* NATA Accreditation does not cover the performance of pocket penetrometer readings.

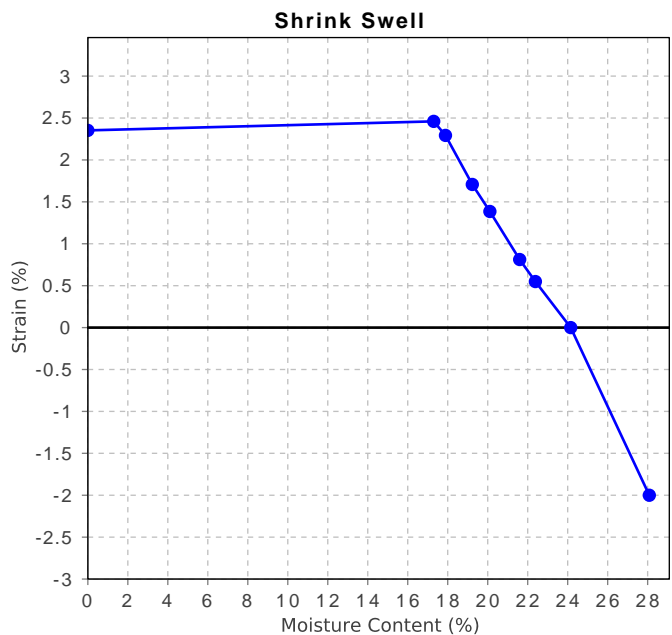
Shrink Swell Index (AS 1289 7.1.1 & 2.1.1)	
Iss (%)	1.9
Visual Description	Clay
* Shrink Swell Index (Iss) reported as the percentage vertical strain per pF change in suction.	
Core Shrinkage Test	
Shrinkage Strain - Oven Dried (%)	2.4
Estimated % by volume of significant inert inclusions	1
Cracking	Slightly Cracked
Crumbling	No
Moisture Content (%)	24.2
Swell Test	
Initial Pocket Penetrometer (kPa)	500
Final Pocket Penetrometer (kPa)	380
Initial Moisture Content (%)	46.1
Final Moisture Content (%)	28.1
Swell (%)	2.0
* NATA Accreditation does not cover the performance of pocket penetrometer readings.

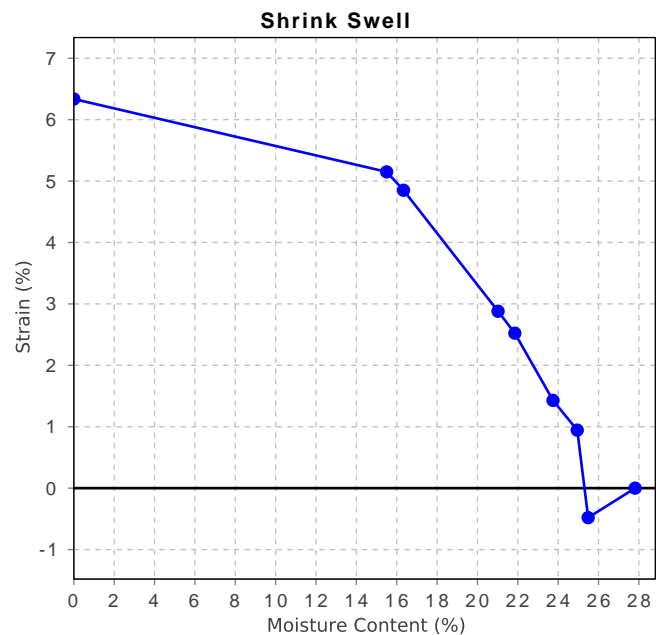
Shrink Swell Index (AS 1289 7.1.1 & 2.1.1)	
Iss (%)	3.7
Visual Description	Clay
* Shrink Swell Index (Iss) reported as the percentage vertical strain per pF change in suction.	
Core Shrinkage Test	
Shrinkage Strain - Oven Dried (%)	6.3
Estimated % by volume of significant inert inclusions	3
Cracking	Slightly Cracked
Crumbling	Yes / No
Moisture Content (%)	27.8
Swell Test	
Initial Pocket Penetrometer (kPa)	250
Final Pocket Penetrometer (kPa)	290
Initial Moisture Content (%)	24.1
Final Moisture Content (%)	25.5
Swell (%)	0.5
* NATA Accreditation does not cover the performance of pocket penetrometer readings.

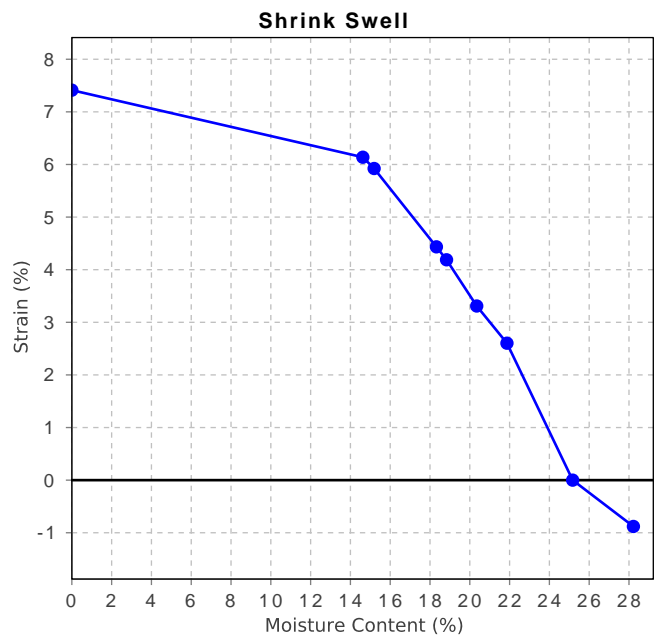
Shrink Swell Index (AS 1289 7.1.1 & 2.1.1)	
Iss (%)	4.4
Visual Description	Clay
* Shrink Swell Index (Iss) reported as the percentage vertical strain per pF change in suction.	
Core Shrinkage Test	
Shrinkage Strain - Oven Dried (%)	7.4
Estimated % by volume of significant inert inclusions	2
Cracking	Uncracked
Crumbling	No
Moisture Content (%)	25.2
Swell Test	
Initial Pocket Penetrometer (kPa)	480
Final Pocket Penetrometer (kPa)	410
Initial Moisture Content (%)	29.9
Final Moisture Content (%)	28.2
Swell (%)	0.9
* NATA Accreditation does not cover the performance of pocket penetrometer readings.

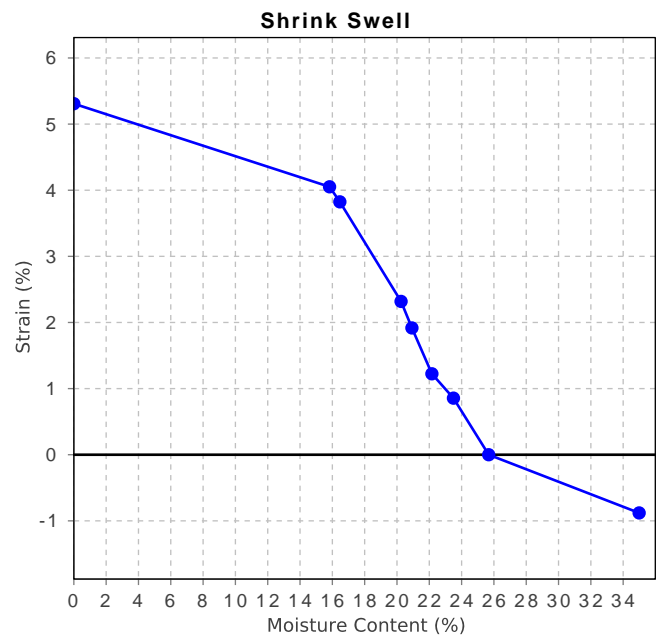
Shrink Swell Index (AS 1289 7.1.1 & 2.1.1)	
Iss (%)	3.2
Visual Description	Clayey Sand
* Shrink Swell Index (Iss) reported as the percentage vertical strain per pF change in suction.	
Core Shrinkage Test	
Shrinkage Strain - Oven Dried (%)	5.3
Estimated % by volume of significant inert inclusions	2
Cracking	Uncracked
Crumbling	No
Moisture Content (%)	25.7
Swell Test	
Initial Pocket Penetrometer (kPa)	270
Final Pocket Penetrometer (kPa)	230
Initial Moisture Content (%)	25.7
Final Moisture Content (%)	35.0
Swell (%)	0.9
* NATA Accreditation does not cover the performance of pocket penetrometer readings.

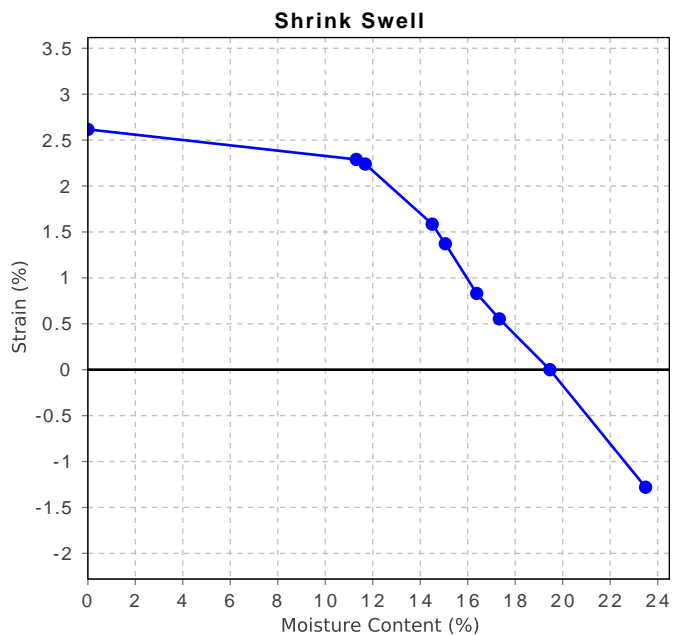
Shrink Swell Index (AS 1289 7.1.1 & 2.1.1)	
Iss (%)	1.8
Visual Description	Clay
* Shrink Swell Index (Iss) reported as the percentage vertical strain per pF change in suction.	
Core Shrinkage Test	
Shrinkage Strain - Oven Dried (%)	2.6
Estimated % by volume of significant inert inclusions	2
Cracking	Moderately Cracked
Crumbling	No
Moisture Content (%)	19.5
Swell Test	
Initial Pocket Penetrometer (kPa)	>600
Final Pocket Penetrometer (kPa)	470
Initial Moisture Content (%)	18.7
Final Moisture Content (%)	23.5
Swell (%)	1.3
* NATA Accreditation does not cover the performance of pocket penetrometer readings.

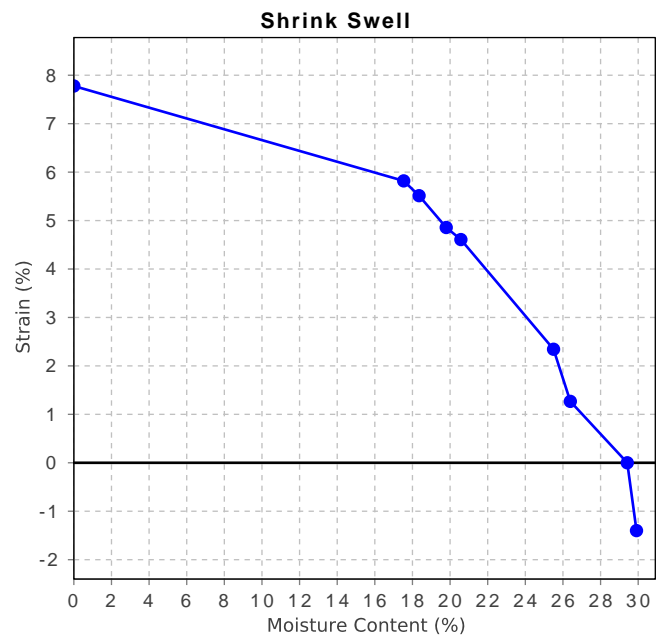
Shrink Swell Index (AS 1289 7.1.1 & 2.1.1)	
Iss (%)	4.7
Visual Description	Clay
* Shrink Swell Index (Iss) reported as the percentage vertical strain per pF change in suction.	
Core Shrinkage Test	
Shrinkage Strain - Oven Dried (%)	7.8
Estimated % by volume of significant inert inclusions	3
Cracking	Uncracked
Crumbling	No
Moisture Content (%)	29.4
Swell Test	
Initial Pocket Penetrometer (kPa)	460
Final Pocket Penetrometer (kPa)	330
Initial Moisture Content (%)	25.4
Final Moisture Content (%)	29.9
Swell (%)	1.4
* NATA Accreditation does not cover the performance of pocket penetrometer readings.

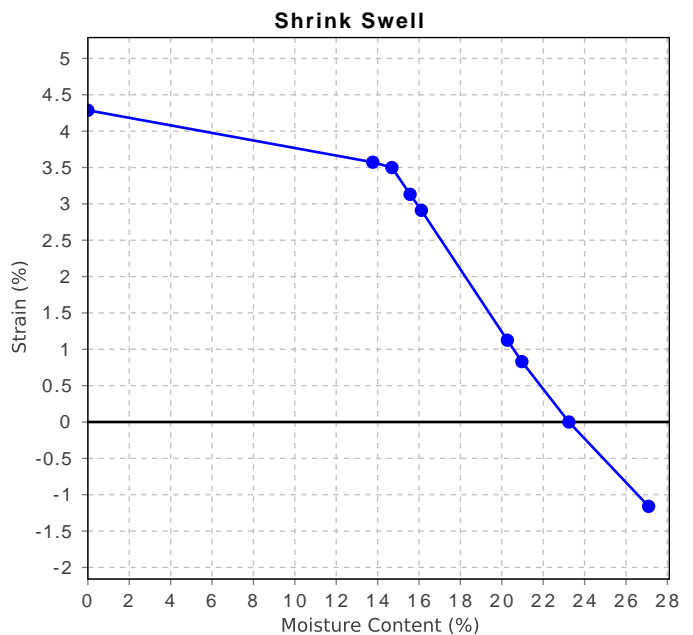
Shrink Swell Index (AS 1289 7.1.1 & 2.1.1)	
Iss (%)	2.7
Visual Description	Clay
* Shrink Swell Index (Iss) reported as the percentage vertical strain per pF change in suction.	
Core Shrinkage Test	
Shrinkage Strain - Oven Dried (%)	4.3
Estimated % by volume of significant inert inclusions	2
Cracking	Moderately Cracked
Crumbling	No
Moisture Content (%)	23.2
Swell Test	
Initial Pocket Penetrometer (kPa)	500
Final Pocket Penetrometer (kPa)	470
Initial Moisture Content (%)	23.7
Final Moisture Content (%)	27.1
Swell (%)	1.2
* NATA Accreditation does not cover the performance of pocket penetrometer readings.

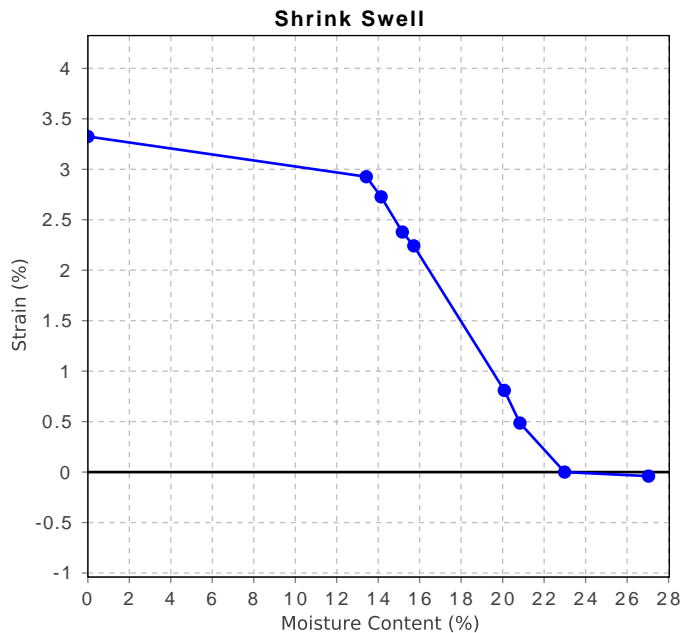
Shrink Swell Index (AS 1289 7.1.1 & 2.1.1)	
Iss (%)	1.9
Visual Description	Clay
* Shrink Swell Index (Iss) reported as the percentage vertical strain per pF change in suction.	
Core Shrinkage Test	
Shrinkage Strain - Oven Dried (%)	3.3
Estimated % by volume of significant inert inclusions	4
Cracking	Slightly Cracked
Crumbling	No
Moisture Content (%)	23.0
Swell Test	
Initial Pocket Penetrometer (kPa)	280
Final Pocket Penetrometer (kPa)	300
Initial Moisture Content (%)	23.8
Final Moisture Content (%)	27.0
Swell (%)	0.0
* NATA Accreditation does not cover the performance of pocket penetrometer readings.

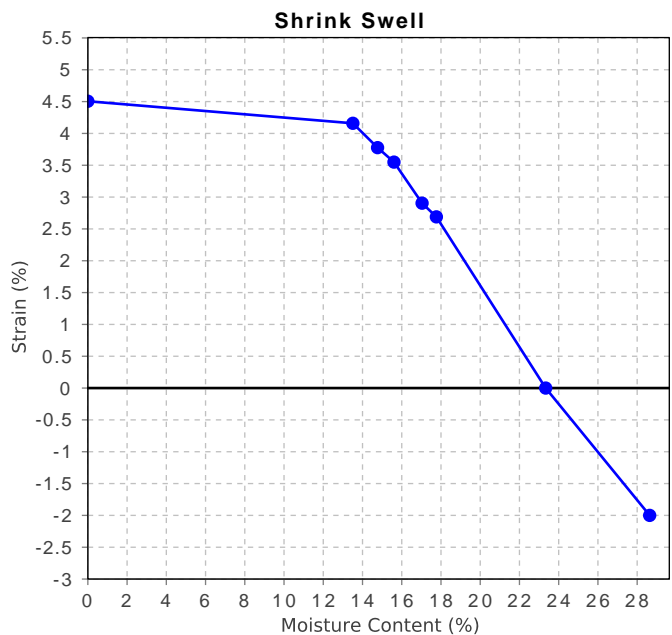
Shrink Swell Index (AS 1289 7.1.1 & 2.1.1)	
Iss (%)	3.1
Visual Description	Clay
* Shrink Swell Index (Iss) reported as the percentage vertical strain per pF change in suction.	
Core Shrinkage Test	
Shrinkage Strain - Oven Dried (%)	4.5
Estimated % by volume of significant inert inclusions	2
Cracking	Slightly Cracked
Crumbling	No
Moisture Content (%)	23.3
Swell Test	
Initial Pocket Penetrometer (kPa)	>600
Final Pocket Penetrometer (kPa)	450
Initial Moisture Content (%)	23.9
Final Moisture Content (%)	28.6
Swell (%)	2.0
* NATA Accreditation does not cover the performance of pocket penetrometer readings.

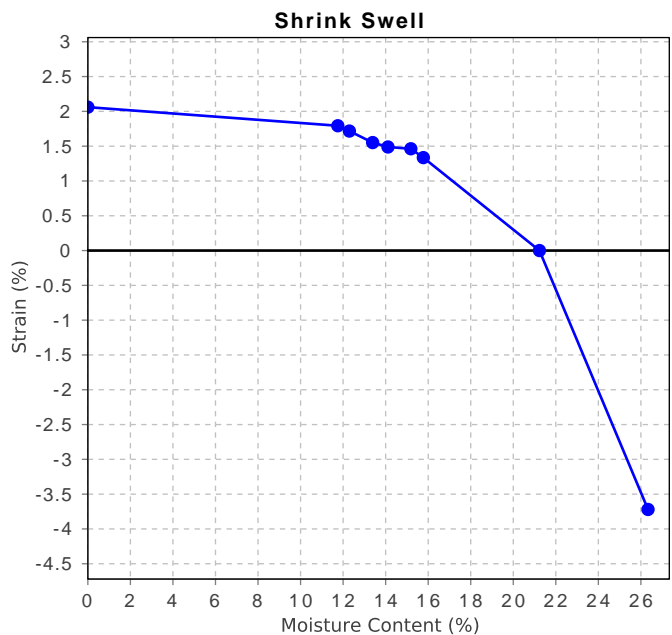
Shrink Swell Index (AS 1289 7.1.1 & 2.1.1)	
Iss (%)	2.2
Visual Description	Clay
* Shrink Swell Index (Iss) reported as the percentage vertical strain per pF change in suction.	
Core Shrinkage Test	
Shrinkage Strain - Oven Dried (%)	2.1
Estimated % by volume of significant inert inclusions	3
Cracking	Moderately Cracked
Crumbling	No
Moisture Content (%)	21.2
Swell Test	
Initial Pocket Penetrometer (kPa)	>600
Final Pocket Penetrometer (kPa)	440
Initial Moisture Content (%)	19.3
Final Moisture Content (%)	26.3
Swell (%)	3.7
* NATA Accreditation does not cover the performance of pocket penetrometer readings.

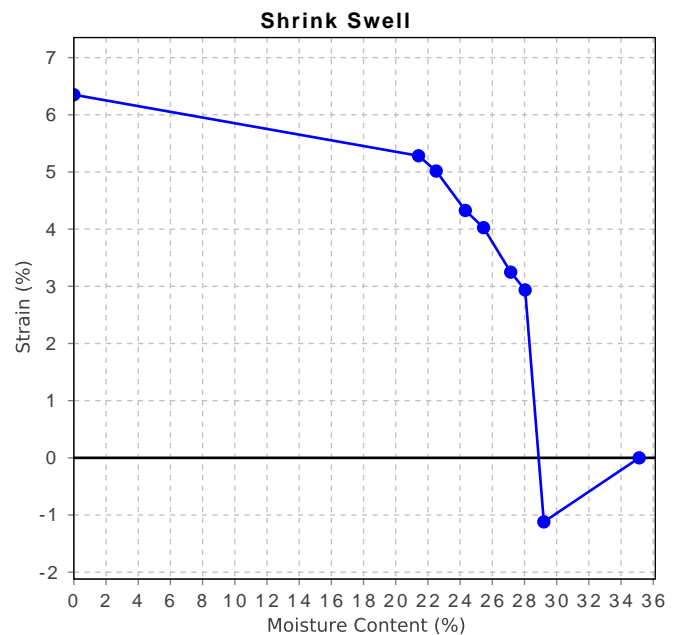
Shrink Swell Index (AS 1289 7.1.1 & 2.1.1)	
Iss (%)	3.8
Visual Description	Clay
* Shrink Swell Index (Iss) reported as the percentage vertical strain per pF change in suction.	
Core Shrinkage Test	
Shrinkage Strain - Oven Dried (%)	6.4
Estimated % by volume of significant inert inclusions	3
Cracking	Uncracked
Crumbling	No
Moisture Content (%)	35.1
Swell Test	
Initial Pocket Penetrometer (kPa)	250
Final Pocket Penetrometer (kPa)	240
Initial Moisture Content (%)	25.9
Final Moisture Content (%)	29.2
Swell (%)	1.1
* NATA Accreditation does not cover the performance of pocket penetrometer readings.

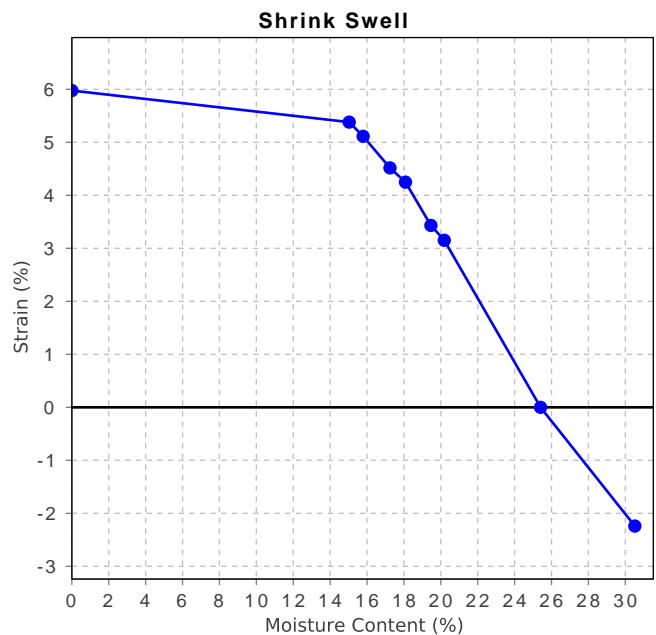
Shrink Swell Index (AS 1289 7.1.1 & 2.1.1)	
Iss (%)	3.9
Visual Description	Clay
* Shrink Swell Index (Iss) reported as the percentage vertical strain per pF change in suction.	
Core Shrinkage Test	
Shrinkage Strain - Oven Dried (%)	6.0
Estimated % by volume of significant inert inclusions	2
Cracking	Slightly Cracked
Crumbling	No
Moisture Content (%)	25.4
Swell Test	
Initial Pocket Penetrometer (kPa)	600
Final Pocket Penetrometer (kPa)	350
Initial Moisture Content (%)	25.3
Final Moisture Content (%)	30.5
Swell (%)	2.2
* NATA Accreditation does not cover the performance of pocket penetrometer readings.
